Towser's Huts, Cobar, New South Wales: Historic Ruin or Ruined History?

HAROLD BOUGHEN

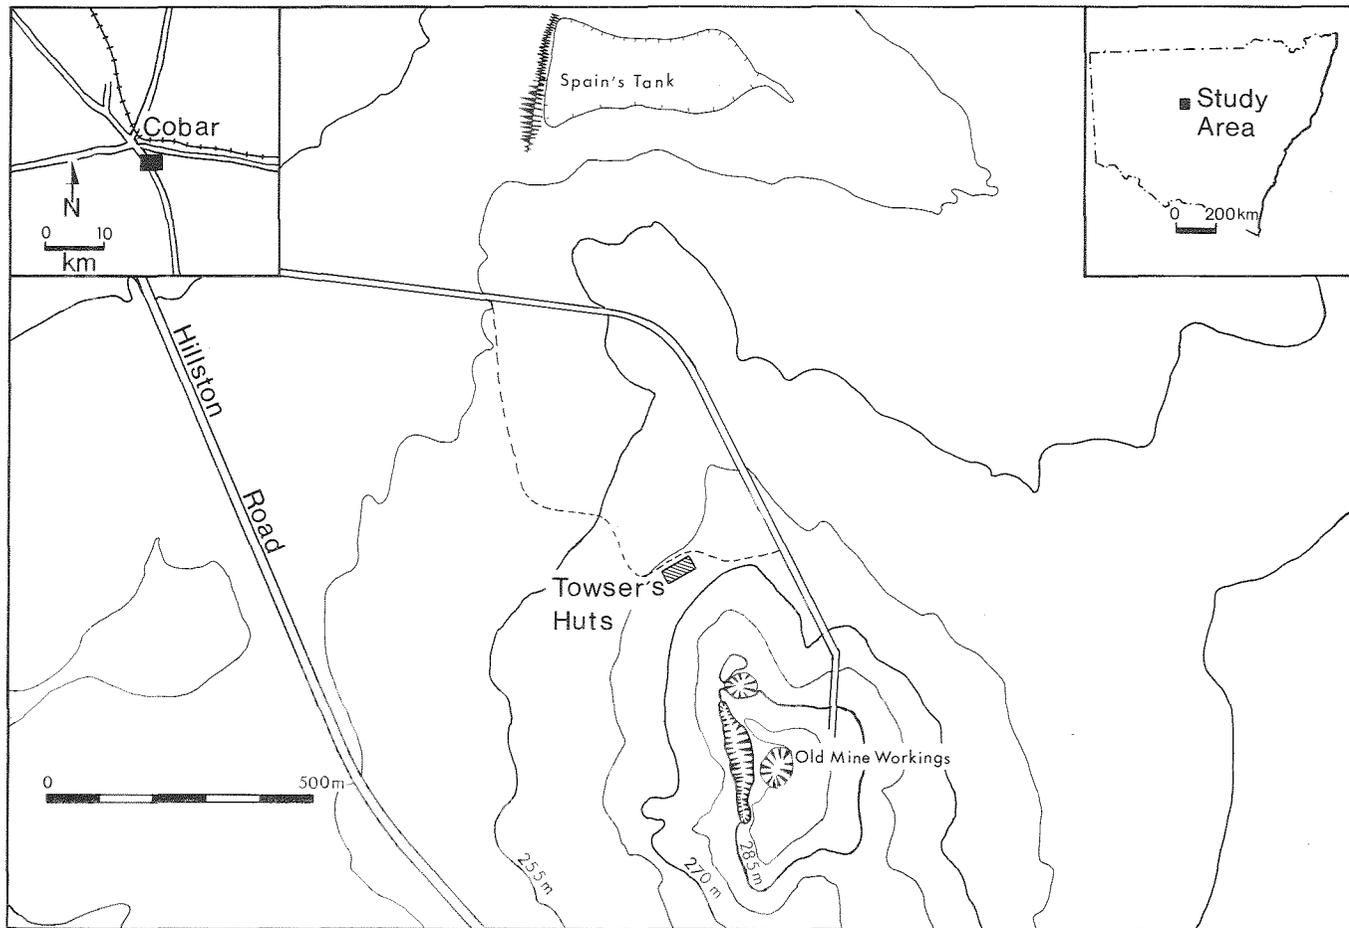
Fig. 2: Location of Towser's Huts. Inset maps show position near Cobar and within New South Wales.

The position of the ruins is shown on a contour map of the general area (Fig. 2) by a block corresponding to Portion 265. The area of major concern, covering the ruins and environs, has been surveyed in some detail by stadia reduction. A general plan of the site appears in Fig. 3. Detailed measurements of each of the buildings have also been carried out by tape and larger scale floor plans of each building have been drawn (Fig. 4).

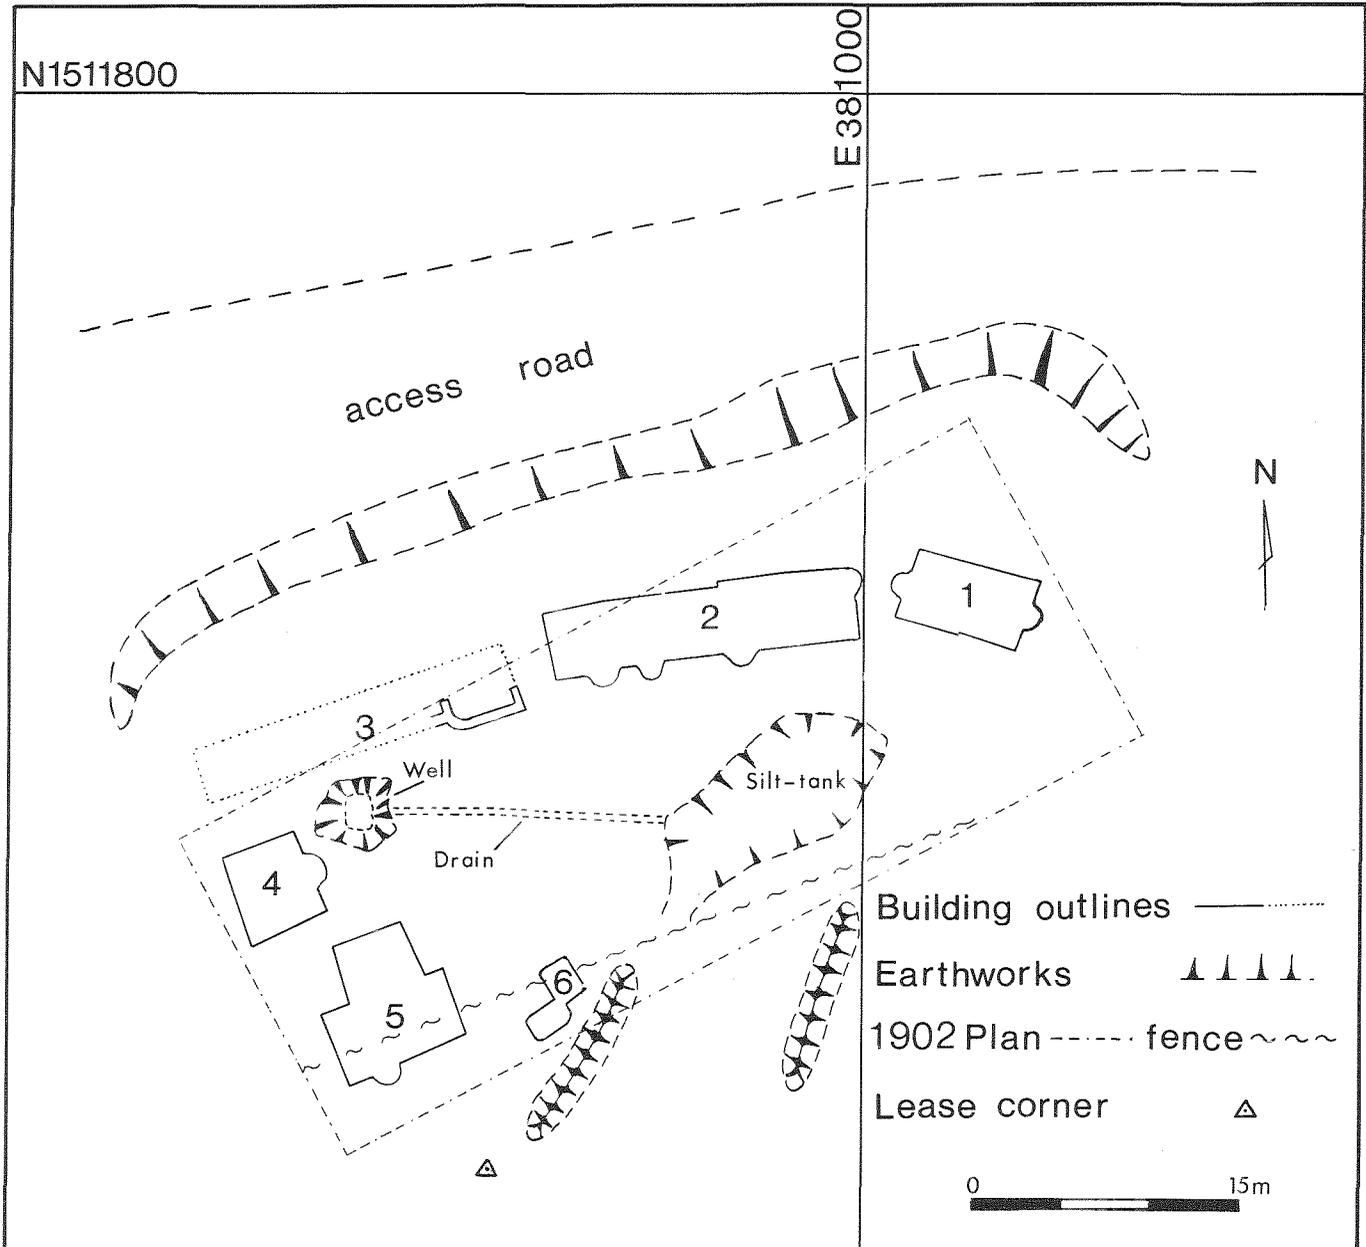
Fig. 3: Plan of Towser's Huts site, showing major features.

There is one other major feature of interest on the site and this is the connected series of excavations and earthworks on the upslope side of the buildings (Fig. 3). This must be considered as a whole, because it almost certainly represents a water-collection system. The linear mounds on the highest parts of the site, have been positioned to direct the sheet runoff from the stony ridge into the large relatively shallow excavation behind Building 2. As well as these two diversion banks, there are other features which are not so well defined further to the east. These might also have served to deflect water into the catchment of the silt-tank. This is how the excavation behind Building 2 has been interpreted and when it filled, clear water would have overflowed via the flagstone-lined channel into the well. The depth of the well is not known but the depression leading into the, just visible, well mouth is over 1m deep. If the well was excavated by the Lions Club, the respondent was not able to recall how far the excavation went.

at 5 pounds.²⁹ When the area surveyed for the 1902 plan is plotted on a modern plan (Fig. 3), some very interesting features come to light. The line of the northern boundary coincides almost exactly with the limits of recognisable walls of Building 3 and the rubble embankment leading from the limits of the extant wall to the vicinity of the well. Virtually all of the extant remains fall inside the 1902 boundary, except for part of Room G in Building 2. Buildings 4, 5 and 6 are adjacent to and approximately aligned with the boundary. This is suggestive that, as a result of the 1902 survey, Mr Tozzi was obliged to demolish Building 3 which fell largely outside his boundary. It is possible that the step in the front wall of Building 2 may have resulted from an attempt to realign part of this building also. Possibly using the materials from Building 3, Buildings 1 and 2 were extended by adding a room each, and Buildings 4, 5 and 6 were constructed. The stake fence, which is only shown on the 1902 plan within the surveyed area, in all probability would have extended outside that area and around the buildings, delineating what Mr Tozzi thought was his block of land. The alignment of the fence roughly parallels the alignment of the main buildings and the limit of the levelled area in front of them. It also would have run along the southern bank of the silt-tank. It is thought unlikely that the Crown would have been responsible for obligating Mr Tozzi to remove his building. If he was obligated, it was most probably by the mining company whose lease surrounded him. The Cobar Gold Mines Ltd.³⁰ This is purely speculative at this stage. However, it might be possible that records do exist which could confirm the idea.

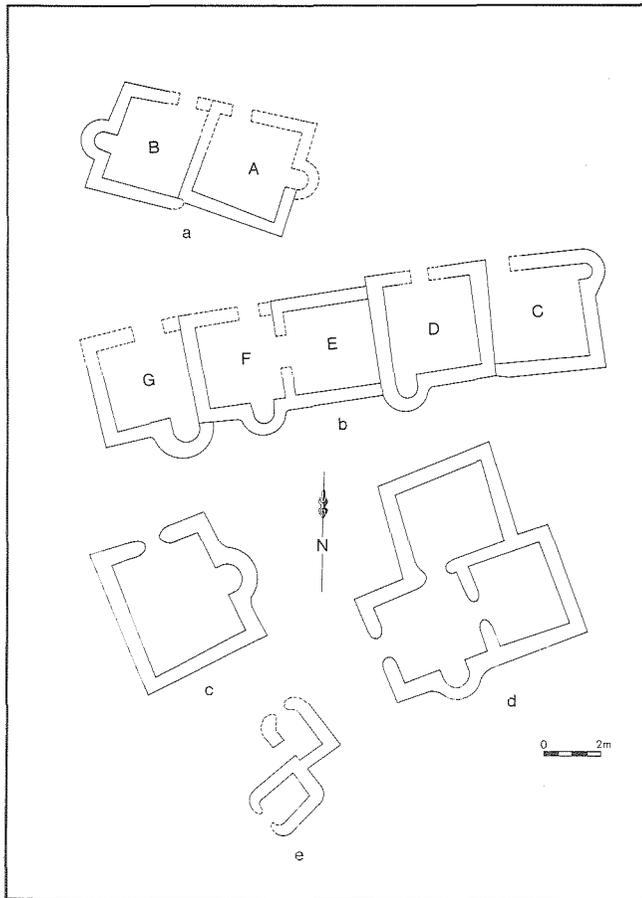
Fig. 4: Floor plans of individual building remains. These are correctly oriented but are not in their correct positions relative to one another. (a) Building 1. (b) Building 2. (c) Building 4. (d) Building 5. (e) Building 6. Broken lines indicate indefinite or inferred parts of structures.

This is the largest building on the site, consisting of a total of five rooms in (what appears to have been) four units (Fig. 4). These were, in all probability, built at different times. In all rooms, the front wall is in the most deteriorated condition

and in the case of the two-room unit the dividing wall is also largely destroyed. Generally, the dividing walls and the rear wall are in a reasonably good condition, standing up to 2.2m high. These walls have probably survived better due, in the case of the dividing walls, to the lack of openings such as doors and windows, and due to the buttress of soil and rubble behind the rear walls. From an examination of the structure remaining, it would appear that Room D was the first to be constructed, followed by Rooms C, and E and F, since the walls of these rooms form butt joints with those of Room D. There is also a significant change in alignment of the rear wall of Room C compared to that of Room D. In addition there is a 300mm step in the line of the front wall between Rooms D and E. Room G was built after Rooms E and F, as evidenced by the butt joint where the chimney of this room joins the rear corner of Room F. There is also a considerable misalignment of the walls of this room, compared with the rest of the building. Generally, Room G is in a very poor state of repair, with the front wall in particular being virtually obliterated.

Each room in this building, except Room E, has one of the semicircular fireplaces so characteristic of the site. Three of these are located in the corner of the room, whilst the fourth is somewhat off-centre in the rear wall. The location in corners is somewhat unusual and at the moment it is considered that this may have resulted from constructional expediency, rather than from considerations of efficiency of heating. The location of the fireplaces in all the other buildings is certainly more conventional.

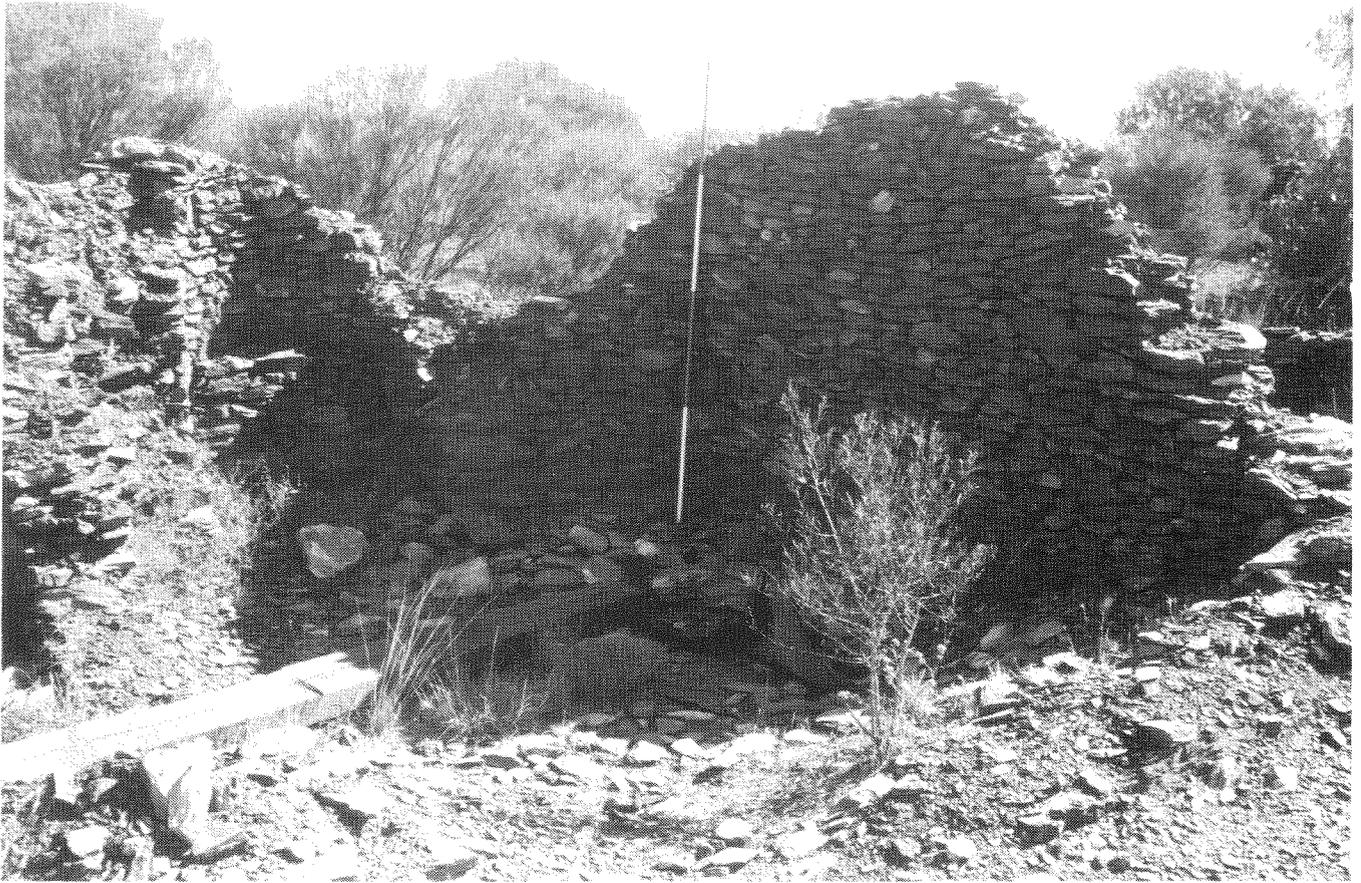
Fig. 5: Building 2, Room F, facing south-west. Note the semicircular fireplace in the rear wall. Scale of 2m in 50cm divisions.

Generally, it was agreed that a large proportion of the ruins, including the two rooms that were restored (Rooms E and F, Fig. 4b), are today in a similar state to that prevailing before the project started. The floors of the two rooms involved were covered with up to 500–700mm of soil and rubble, presumably from the collapsed walls. A similar talus slope existed against the outside walls. Differences from the general recollection included walls being higher/lower, the dividing wall between the two rooms being virtually complete, including an arched doorway, and that there were definite signs of windows in the front and/or back walls.

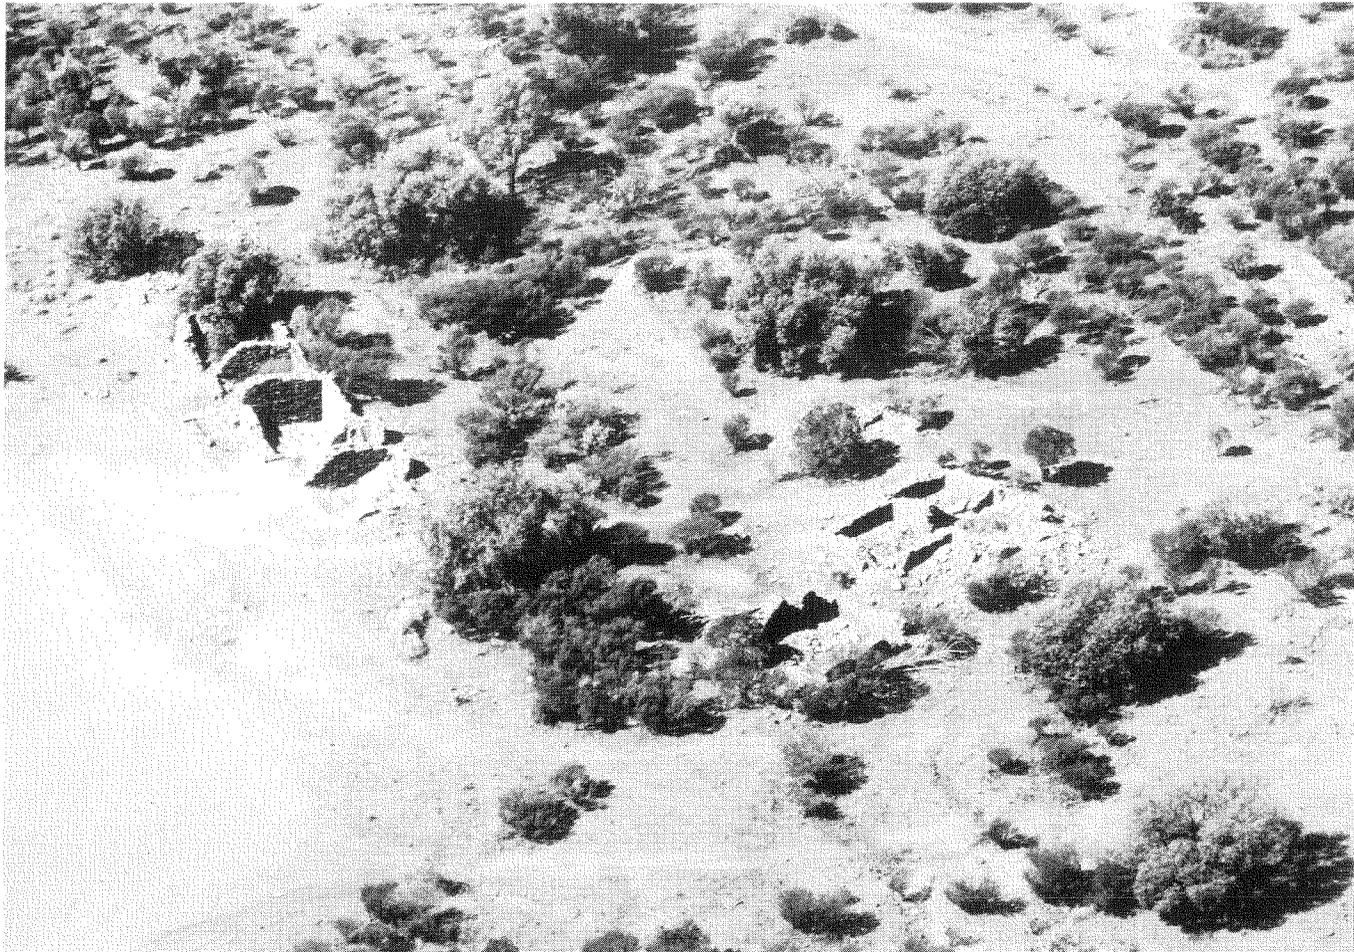
Fig. 6: Aerial photograph of Towser's Huts from the north-west, showing Building 2 to the left and Buildings 4 and 5 to the right. The site of Building 3 is indicated by the thick growth of hop bush (Dodonaea sp.) in the centre foreground. Photograph by Graham Connah, 1.00 p.m., 19 August 1986.

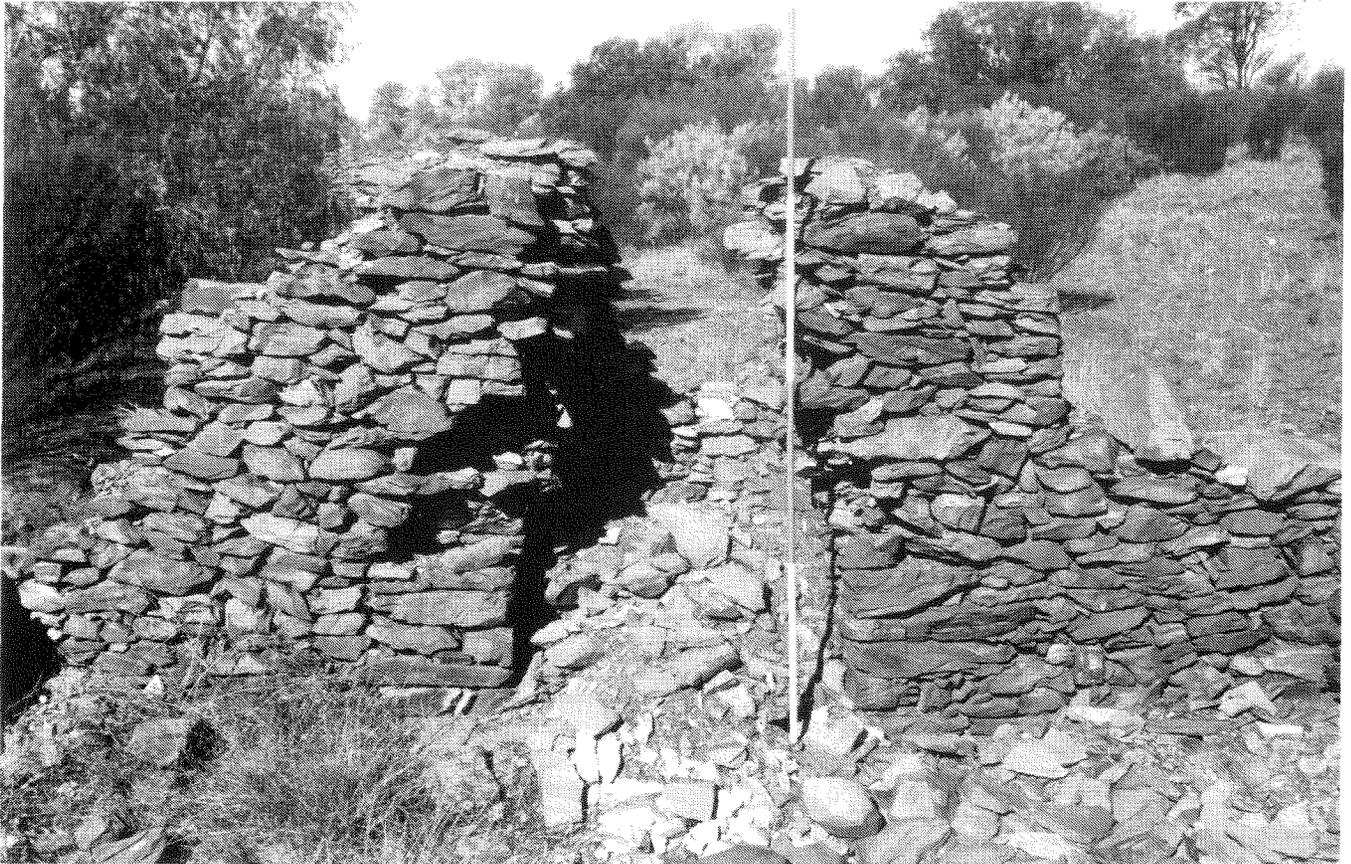
Fig. 7: Fireplace in eastern wall of Building 4. Photograph facing east. Scale of 2m in 50cm divisions.

This building is a single room (Fig. 4) and is obviously the one referred to as a 'dining room' in the item in *The Cobar Age*. The arch of the fireplace is no longer complete, as it apparently was at the time of the article. A photograph of this building of unknown date,²⁸ but possibly from the same period, shows the arch complete but with the remainder of the stonework in the immediate vicinity substantially as it is today. Some impression of the massiveness of this structure but also of the fragility of its current state, may be gauged from Fig. 7. As well as the interest due to the fireplace, this room is interesting because of an example of what appears to be a refinement in building technique, compared with that of the buildings already discussed. This is the curved finish or bullnose jambs of the doorway. In all previous cases, the evidence available suggests that square jambs were the norm. One section of the wall also gives insight into the construction methods used. The cleavage and bedding of the local siltstones produce a tendency to break into wedge-shaped pieces, which have been interleaved from both sides of the wall. A filling of clay and fine stone

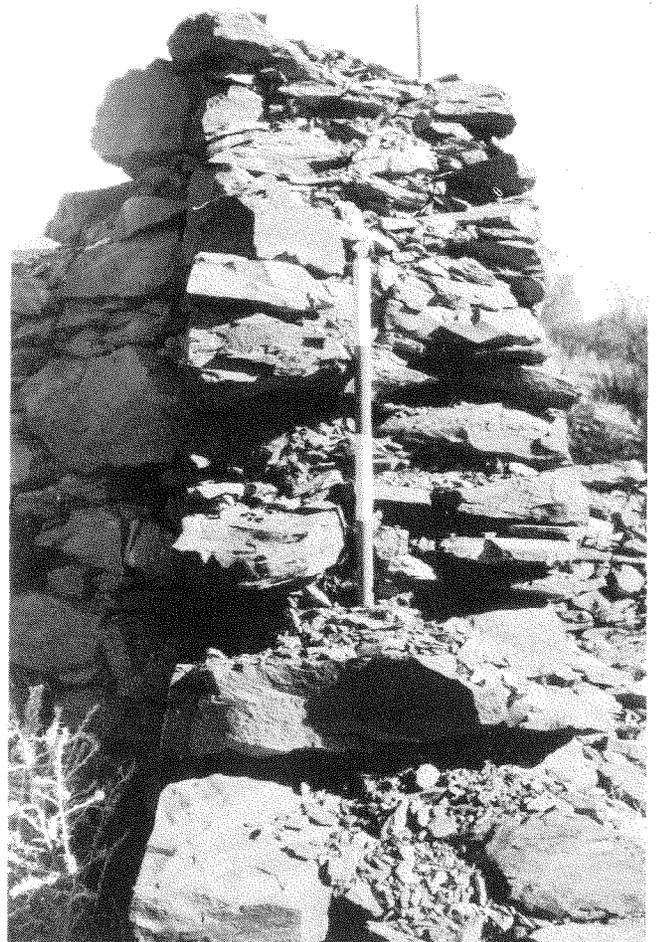
Fig. 8: Cross-section of the eastern wall of Building 4. Photograph facing south. Scale of 40cm in 10cm divisions.

completes the structure and weatherproofs the wall. An occasional large slab serves as a through-stone (Fig. 8). Since this building does not appear on the 1902 plan (Fig. 1), it must be assumed that it post-dates this time.

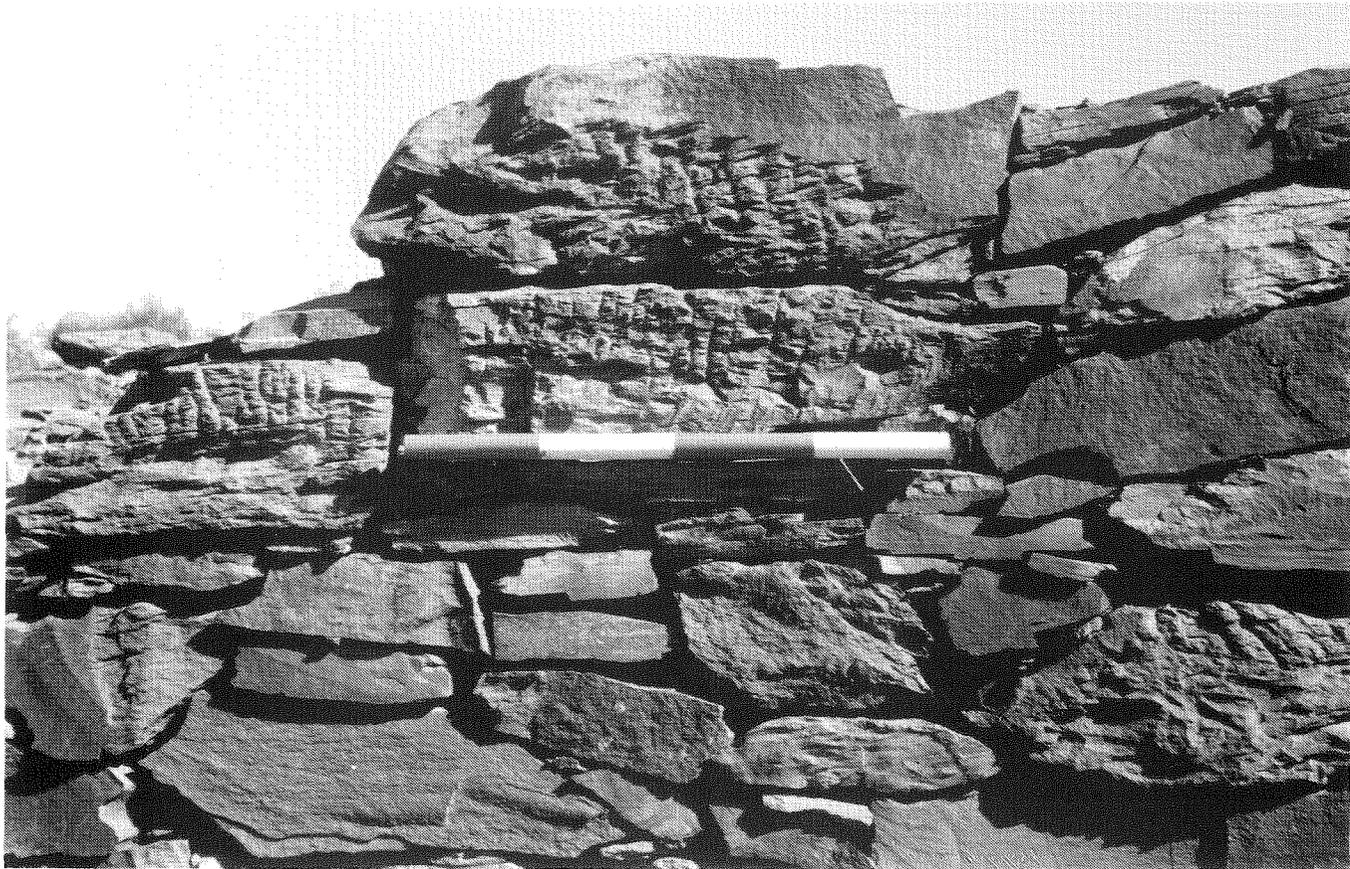
Fig. 9: Dressed stones in the northern wall of Building 5. Photograph facing south. Scale of 40cm in 10cm divisions.

This building consisted of three rooms (Fig. 4) and was referred to as the 'residence of Mr Towser' in the newspaper item of July 1969. The building also has some relatively high walls remaining and the plan and construction methods certainly merit attention. First, there is the departure from the linear format of the previous buildings, with their series of separate rooms. Second, it would appear from the interleaving of the stonework at the corners, that it was built as a unit from the start and not in piecemeal fashion as appears to have been the case with the other multi-room units. Third, it has only one fireplace as distinct from all other buildings, which generally have a fireplace in each room. Fourth, it shows the aesthetic refinements of the bullnose door-jambs on all three doorways, which in one case has required a curved transition from the adjacent wall. Finally, although there is evidence on other buildings, by far the most extensive evidence of the dressing of stone is to be found on this building (Fig. 9). Once again, this building presumably post-dates the 1902 plan (Fig. 1) and it would appear from the extra attention to detail and the coherence of the structure, that it was not a rush job.
