78 South, 166 East: Archaeology in the Ross Dependency, Antarctica

NEVILLE A. RITCHIE

The objective of this paper is to outline archaeological work and problems associated with the management and maintenance of the historic huts in the Ross Dependency, Antarctica. New Zealand, through its agent the Department of Scientific and Industrial Research Antarctic, is concerned about the maintenance of the historic sites in the Dependency, because of their historical significance and its desire to comply with the provision of the Antarctic Treaty which requires all territorial claimants to maintain the historic 'monuments' (as they are called) in their territory. The author is employed by the Department of Conservation.

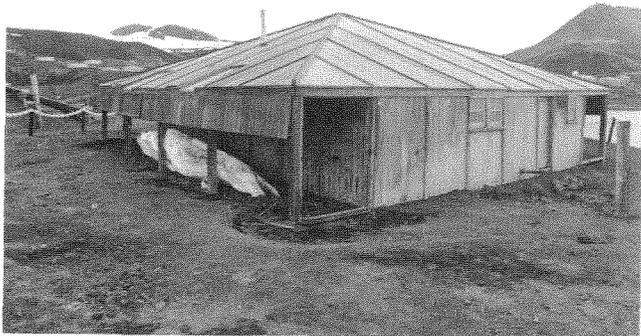
Fig. 2: Scott's 1902-1904 hut at Hut Point, Ross Island. The prefabricated hut, modelled on an Australian outback design, was erected in Melbourne before being taken to Antarctica.

A substantial hut on Hut Point, Ross Island built by Captain R.F. Scott's 'Discovery' expedition was used for storage and entertainment initially, and as a staging base by the later Scott and Shackleton expeditions. The

prefabricated hut was constructed in Melbourne and exhibited there before being taken south by Scott. Painted colour-coded marks on the panels are clearly visible today; in fact, due to weathering they stand in raised relief.

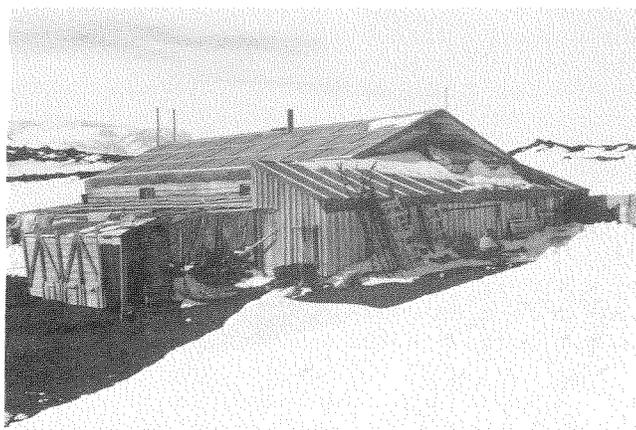
Fig. 3: Scott's Hut at Cape Evans, Ross Island, January 1987.

The major job at Cape Evans for the two seasons of 1987–1988 and 1988–1989 has involved assessment and resolution of problems resulting from snow accumulation against the southeast wall of the hut within the collapsed remains of the 1911 stores annexe. Every year in December-January the snow melts, and melt-water ponds within the trough-like remains of the annexe. Eventually some of it seeps into the interior of the hut causing dampness, high humidity and associated deterioration problems. Short of total reconstruction of the annexe and hence its weatherproofing (which may be financially feasible at a later date), the only practical immediate remedy was to remove all or part of the structural remains of the annexe to decrease the entrapment of snow and melt-water. Obviously, the removal of any part of the annexe takes away a portion of the original fabric which is undesirable, but in this instance, the work was considered necessary to improve the micro-climate and conditions for artefact conservation within the main structure. It was proposed to undertake this work during the summer of 1987–1988 as a systematic excavation and recording project. It constituted the major task during the 1988 season.

The job itself was quite straightforward in theory but proved a bit more difficult in practice. The plan was to remove the collapsed wall of provision cases (salvaging the Colmans Flour boxes which formed the wall in the process), then systematically record and recover any objects below the fallen wall, and finally excavate shallow trenches to drain melt-water away from the structure. After clearing some three metres of snow off the boxes we found they were tightly packed and virtually welded together with ice. Furthermore, the box wood had in effect freeze-dried and become so brittle that it was extremely difficult to remove the boxes without breaking them, despite working slowly and methodically and using all the techniques and technology at our disposal. In the end we had to resort to taking them apart board by board and reassembling them.

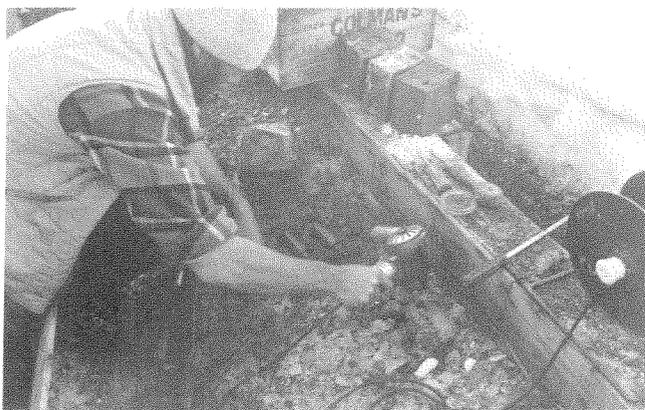
Fig. 4: Using a heatgun to expose artefacts during the excavation of Bowers' camp, Cape Evans. January 1988.

There are two main means of excavating in ice and snow or permafrosted ground. They are dry or mechanical techniques and wet techniques (all of which have specific pros and cons). Dry techniques involve using various tools, notably ice saws, chisels, ice picks, levering bars and other percussive tools (see postscript) to remove ice and expose and free objects. Of the four main wet techniques, direct and indirect solar melting (often used in conjunction with mechanical techniques), hot air melting and using hot water or steam, we were equipped only for the first two. Our hot air melting equipment consisted of a heat gun and an Andrews air heater. Both devices are powered by a petrol generator.

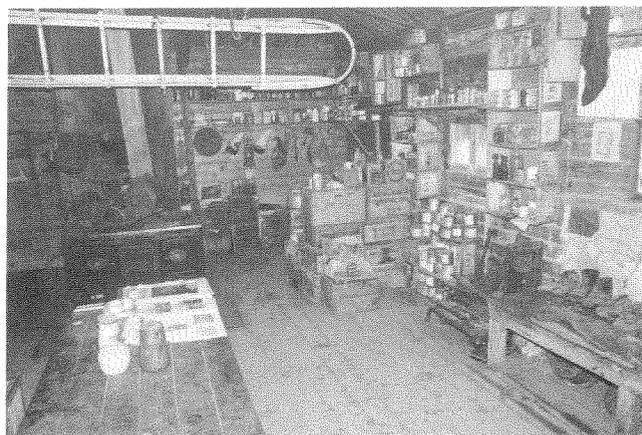
Fig. 5: Part of the interior of Shackleton's 1907-1909 over-wintering hut at Cape Royds, Ross Island.
