# Stone walls near Jindabyne NSW: European fences, not Aboriginal stone arrangements

JOHN PICKARD<sup>1</sup>

*Two sets of stone walls located at Mill Creek and Ironpot Creek near Jindabyne NSW and a pair of parallel lines of stones near Ironpot Creek are believed by some to have been built by Aborigines for spiritual or astronomical purposes. However the structure of both sets of walls is typical of European dry stone walls elsewhere in Australia, and similar to other examples on a nearby property 35 km away. Furthermore, both sets of walls were charted and valued by surveyors as fence improvements on survey plans in the 1880s and 1890s. This paper compares these structures to other examples of European walls and Aboriginal stone arrangements, concluding that they are dry stone walls built in the late nineteenth century as boundary fences on steep rocky slopes. Either Aborigines, or Chinese miners returning from the Kiandra gold rush may have been employed to build them. Explanations invoking Aboriginal spiritual or astronomical uses are improbable and unnecessary. The double row of stones near Ironpot Creek is most likely to be a lockspit marking a reserved road between cadastr

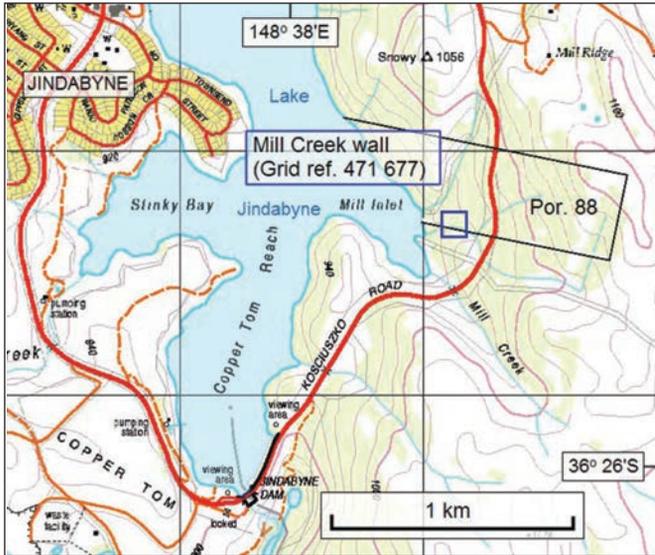
Figure 2: Location of Mill Creek wall. Blue square shows the 100 m grid location provided by Angel John Gallard. Note boundary of Portion 88, Parish of Jinderboine running into the water of Lake Jindabyne. (Jindabyne 8625-3S 1:25,000 topo map 2nd edn. Land and Property Information – Department of Finance and Services 2002).

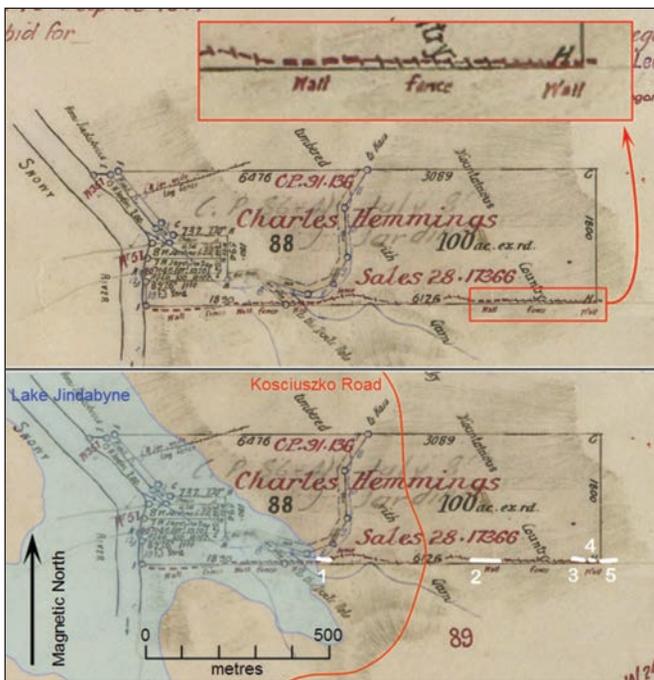
Figure 3: Detail of Surveyor G. Pennefather's 1882 plan of Portion 8, Parish of Jinderboine, County of Wallace (Plan 2480.1604). Upper: showing location of log fence in the north-west corner, and 1886 annotations (red ink) of "Wall" and "fence" along the southern boundary. Enlarged inset from south-east corner shows how fence sections were marked with a crossed line, and walls with thicker dashed lines. Lower: GPSed location of five sections of wall (numbered white dashes) plotted on a georeferenced plan of Portion 88. Kosciuszko Road (red) and top water-level of Lake Jindabyne (blue tint) are also shown. (Land and Property Information – Department of Finance and Services 2002).

William Jardine held two small freehold portions (7 and 8, Parish of Jinderboine, County of Wallace) (NSW Land Titles Office) on the Snowy River where he had his flour mill (Figure 3, upper). He selected the 100 acres of Portion 88, out of the *East Jindabyne Run*, as an Additional Conditional Purchase (ACP 81.116) on 17 February 1881, but forfeited this on 31 December 1885. Within a few months, his youngest son, James Jardine, took up the block as a Conditional Purchase (CP 86.41) on 8 July 1886, but on 24 September 1890 this also was forfeited for non-residence. Subsequent changes in tenure and ownership are not relevant to the origins of the wall, and are not pursued further.

Surveyor G. Pennefather surveyed Portion 88 in July 1882, valuing a short log fence in the north-west corner at £1, but recording no boundary fences (5 July 1882) (Figure 3 upper). A few days later, he also surveyed Portion 89, adjoining Portion 88 to the south. His plan (10 July 1882) does not show any form of fence along the common boundary with Portion 88. Although his survey book, including Portion 88, seems to have been lost, his field book for Portion 89 survives but lacks any additional information (Field book O2297, Land and Property Information NSW). Four years later, on 27 August 1886, most likely in relation to James Jardine's CP 86.41, he inspected the block again annotating his 1882 plan "Wall" and "fence" running along or close to the southern boundary of the portion (Figure 3 upper and inset).

Close inspection of Pennefather's annotations (Figure 3 upper) show that he recorded five sections of wall, separated by fences along the southern boundary (total length 8016 links, 80.16 chains, 1.0 miles, 1.6 km). He valued 11 chains (221 m) of wall, and 27½ chains (553 m) of log fencing at half value, i.e. along a boundary. If this log fence were on the southern boundary, this leaves 41½ chains (835 m) unaccounted for, even though he showed the entire boundary either fenced or walled.

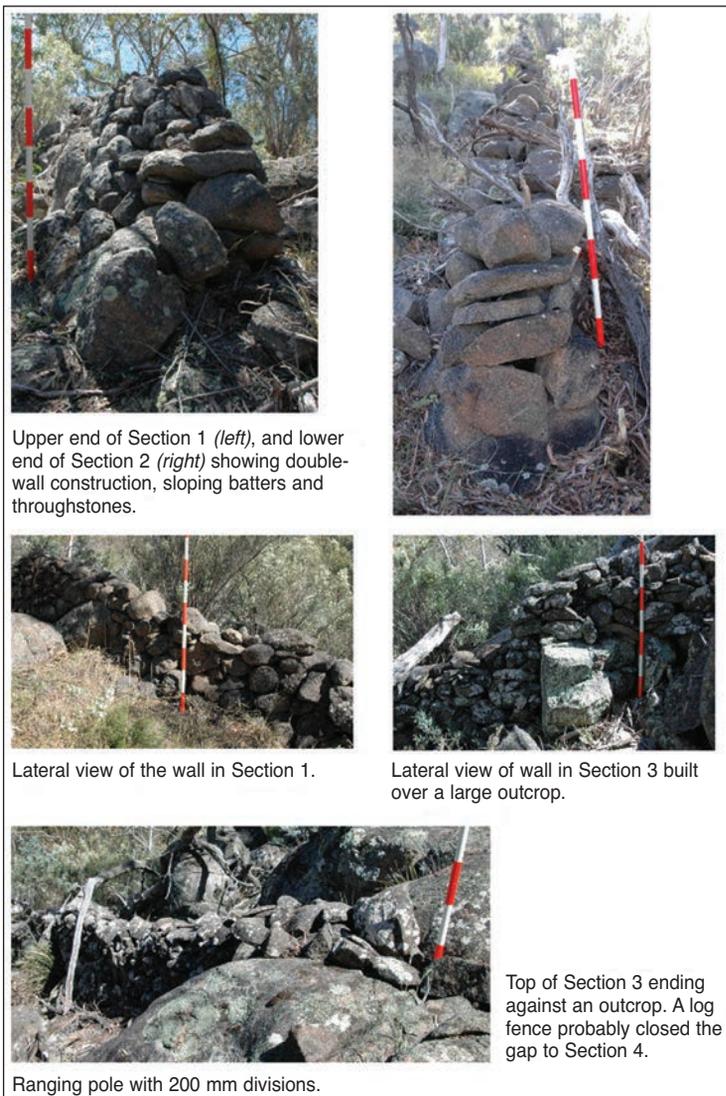
Figure 4: The granite wall at Mill Creek.

Section 1 (45 m) runs up a steep bouldery slope from the lake, ending on a small bench with few outcropping boulders (Figure 4). There is a long gap (400 m) to the lower end of Section 2 (79 m) uphill of the Kosciuszko Road. The gap has some steeper bouldery slopes, but is generally free of outcrops. Section 2 ends against a prominent cluster of tors below a flat bench. The 200 m gap to the bottom of Section 3 is a mix of flat, outcrop-free slope and some steeper sections with numerous boulders. Section 3 (32 m) runs up a bouldery slope, ending against a large outcrop. A short gap (13 m) leads to Section 4 (15 m), which also ends against an outcrop. Section 5 (44 m) starts 19 m above Section 4, and ends on some small outcrops below the crest of the ridge. Surprisingly, this section runs beyond the boundary of Portion 88. This may be due to an error in rectifying the plan, or because the builders may have missed the boundary corner marker.

The walls are quite low, generally <1 m except close to large boulders (Figure 4). At the tops of Sections 3, 4 and 5, the wall peters out against outcrops of varying size. The generally rounded boulders used give the walls a very irregular appearance compared with the well-made basalt walls of the Western Districts of Victoria, and those at Ironpot Creek (described below). However, the structure is similar: a double row of boulders with basal width varying from 0.8 to 1.2 m. Side batters are irregular, and there is relatively little plugging, few throughstones and no distinct coping, except for a very short length of Section 5 that is capped with flat rocks (see Vines 1990:37 for definitions of wall terms).

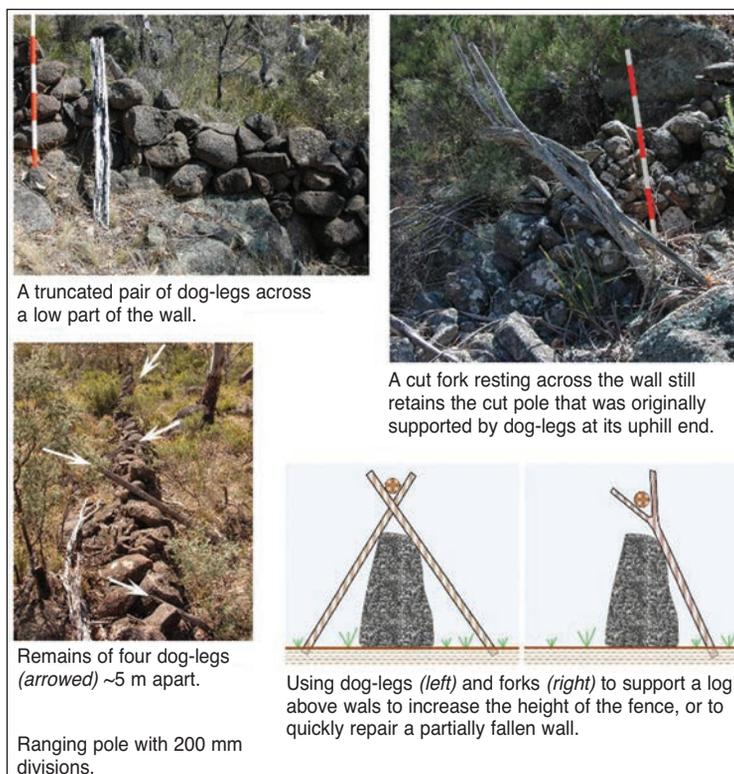
Figure 5: Dog-legs and forks used to increase the height of the Mill Creek wall.

Although the basic structure of the wall is that of a European dry stone wall, the most unusual feature is a series of cut poles and forks resting against the wall, especially in Sections 2, 3 and 4. Some are regularly spaced approximately 4–5 m apart, and at least one fork still has a cut pole resting in its crutch (Figure 5). These poles and forks differ from random tree and branch falls, which are generally crooked, often have branches attached, and have broken ends with no evidence of being cut with an axe. The cut poles and forks are the remains of dog-legs (Pickard 2013) which supported a log above the low wall, thus increasing its effectiveness as a fence. It is not possible to determine when the dog-legs and forks were added to the wall. They could have been incorporated during construction, or subsequently as cheap repairs. Although dog-legs were a common feature of early log and brush fences, this is apparently the first record of their use with dry stone walls, making this a very rare form of composite wall.

100 mm diameter cut close to the ground. This style of cutting, adjacent to fences, is identical to that seen on many other stumps seen elsewhere in Australia that are definitely known to have been cut for fencing. Poles from the Mill Creek stump were probably used in log fences across the gap, or as dog-legs and the upper poles they originally supported.

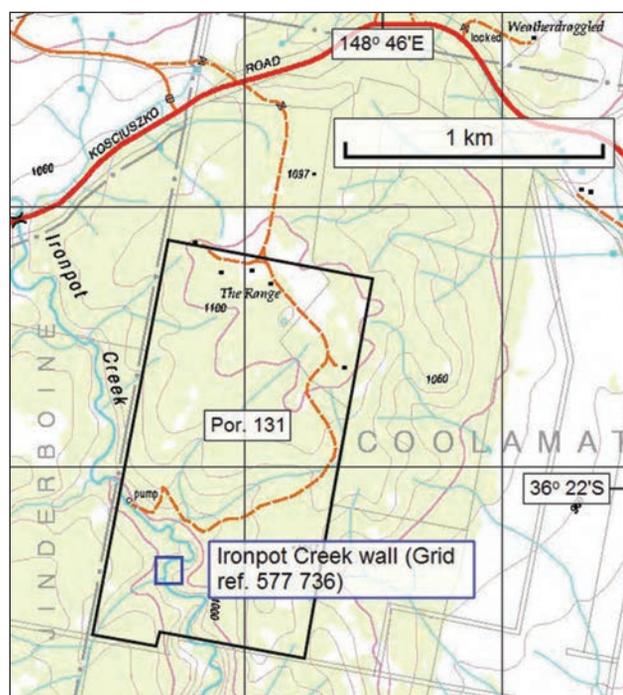
Figure 6: Location of Ironpot Creek wall in south-west corner of Portion 131, Parish of Coolamatong. Blue square shows the 100 m grid square location provided by Angel John Gallard. (Source: Cootralantra 8325-2N 1:25,000 topo map 2nd edn. Land and Property Information – Department of Finance and Services 2002).

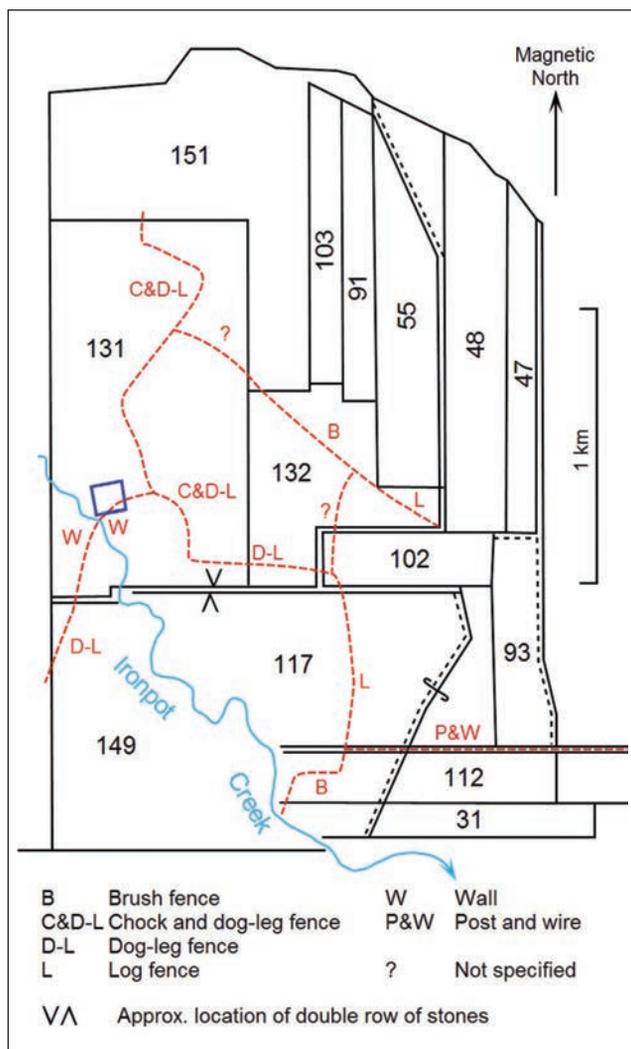
Figure 9: Index map of historic portions in Parish of Coolamatong, County of Wallace near Ironpot Creek. Blue square shows 100 m grid location provided by Angel John Gallard in the south-west corner of Portion 131. Fences (dashed red lines) are compiled from portion and run plans (1886–1908), with structures shown by letters. Note approximate location of double row of stones on reserved road between Portions 131 and 117. A strip of Crown land along both sides of Ironpot Creek south of Portion 131 is omitted for clarity.

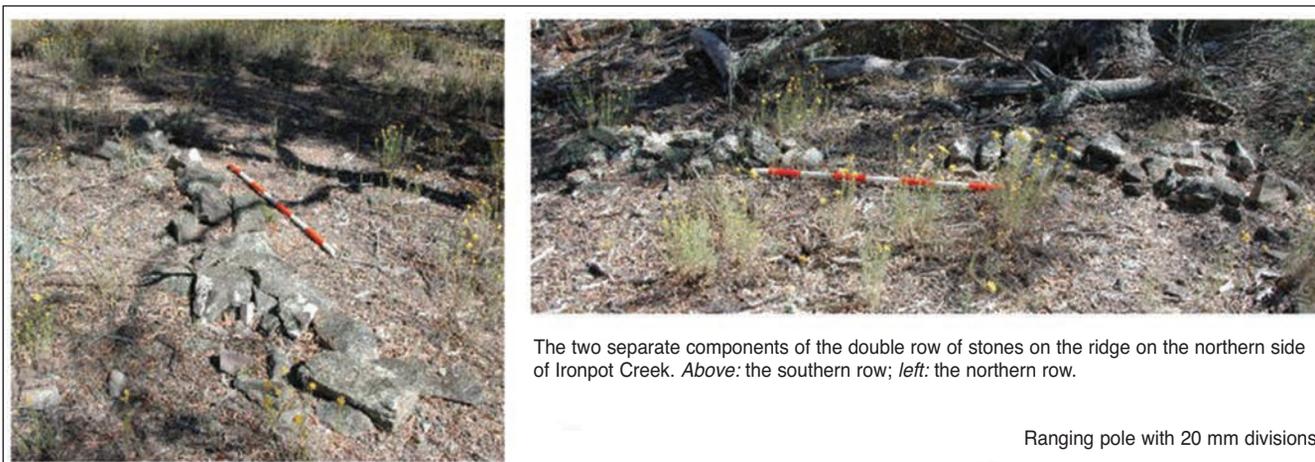
The two separate components of the double row of stones on the ridge on the northern side of Ironpot Creek. Above: the southern row; left: the northern row.

Ranging pole with 20 mm divisions.

Figure 10: Double row of stones on northern side of Ironpot Creek.

The final stone arrangements to be considered are those near Ironpot Creek, described by Gallard as 'two sets of small stone lines nearby on the top of the ridge [above Ironpot Creek], lying east-west, which mimic the layout of the bigger walls' (Smith 2011). Given their location and orientation, the simplest explanation for the double row are lockspits marking the reserved road between Portions 117 and 131, and probably placed by Surveyor Pennefather in October 1889. Although the rules for surveyors required trenched lockspits at the time of his survey, lines of rocks were permitted a few years later.
